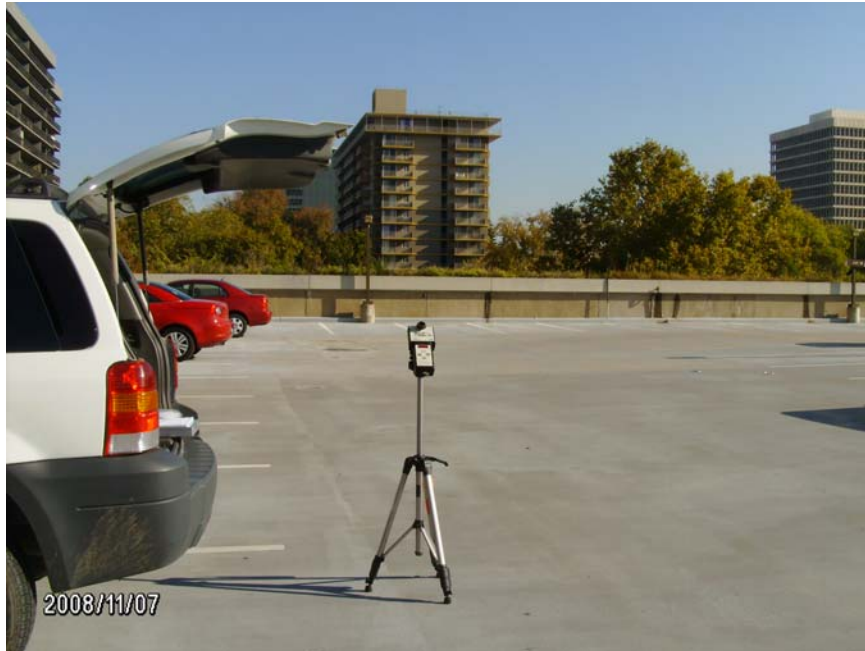
- 1) Image of ambient air sampling location at Garage Rooftop of BOE building (Subject Building) located at 450 N Street, Sacramento.

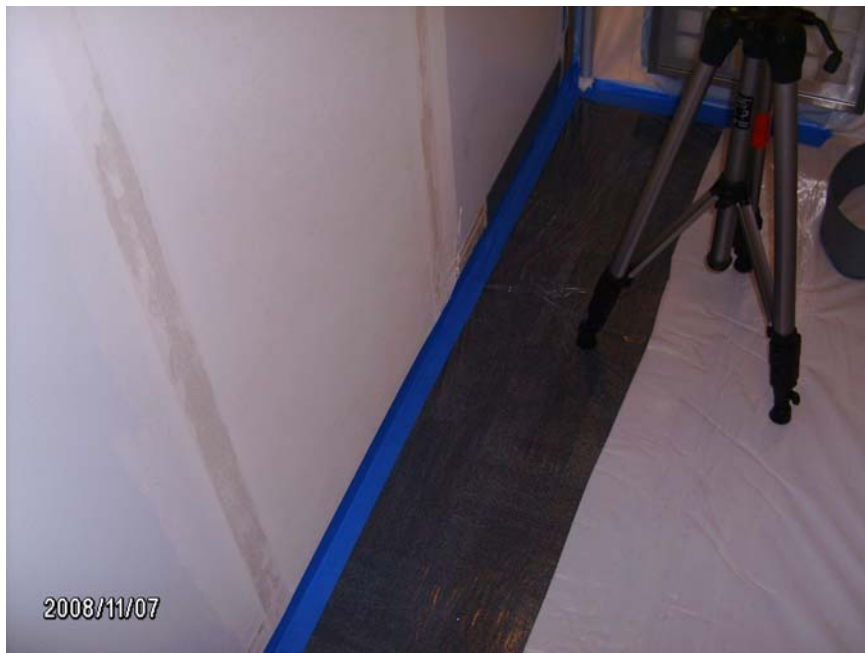
- 2) Image of air sampling equipment located within interior of LCD-C-1 containment area at time of assessment. Note sheetrock repair at area formerly removed for inspection.

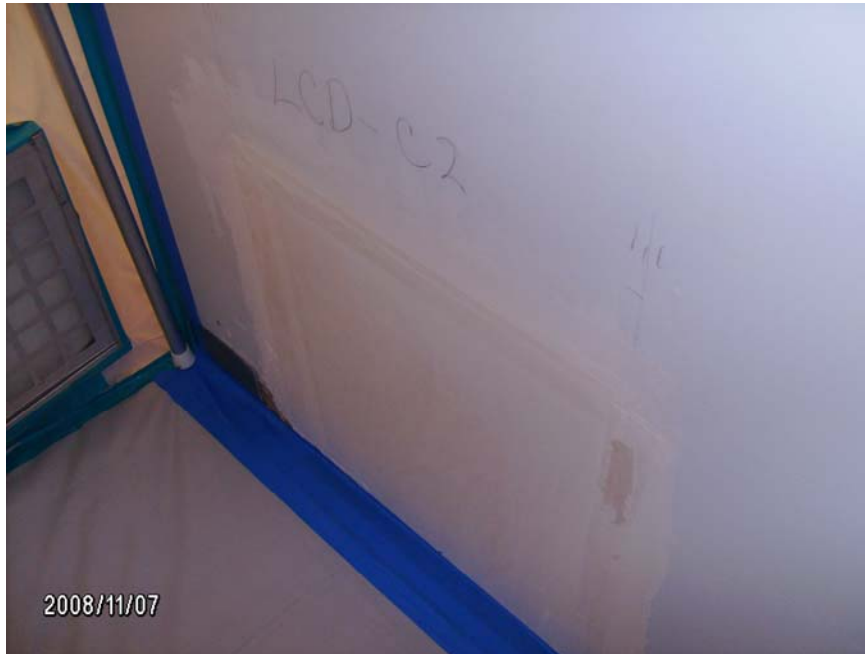
3) Image of reconstructed wall within interior of containment LCD-C-2 at time of assessment.

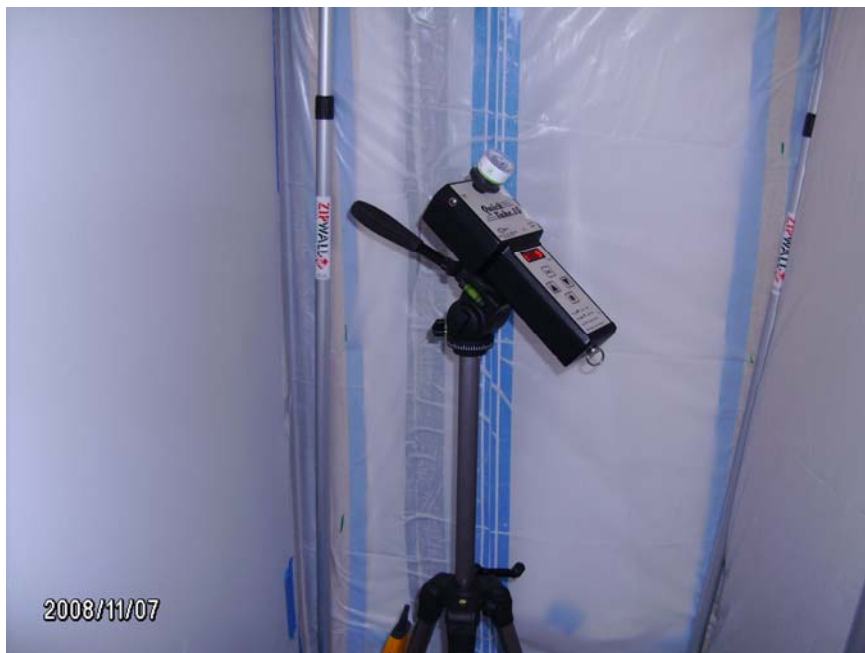
4) Image of interior entry chamber construction and air sampling activity performed within LCD-C-2 at time of assessment.

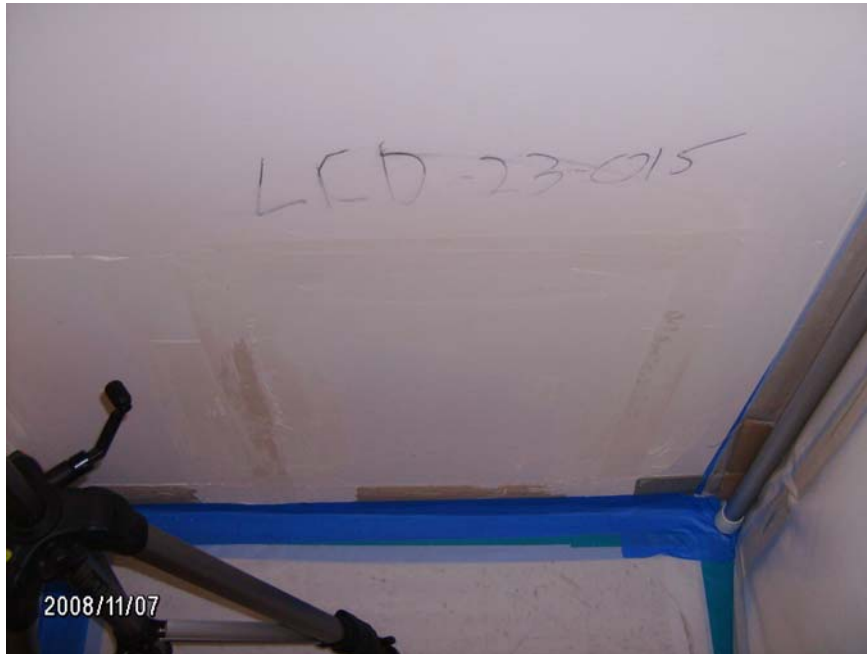
- 5) Image of baseboard removal, wall repair, and air sampling activity performed within LCD-C-3 at time of assessment.

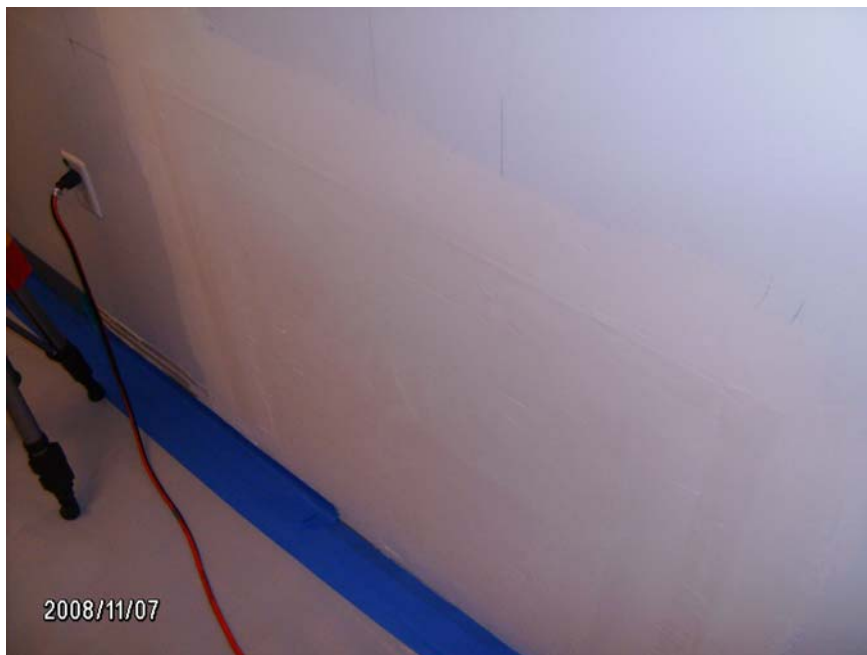
- 6) Image of baseboard removal, wall repair, and air sampling activity performed within LCD-C-4 at time of assessment.

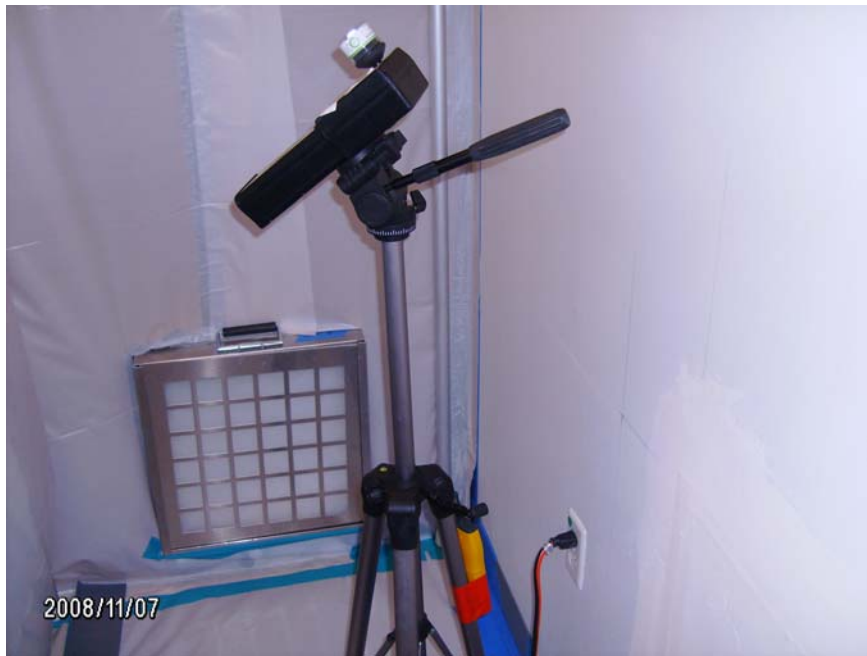
- 7) Image of air sampling equipment and HEPA filtered negative air machine as viewed from interior side of containment LCD-C-4 at time of assessment.

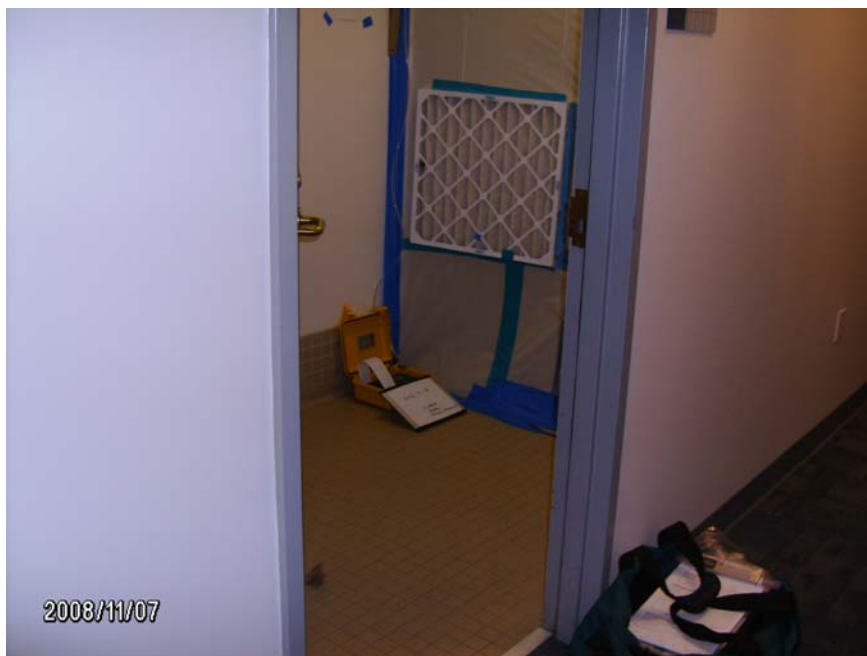
- 8) Image from hallway of LCD-C-5 containment area erected at restroom entry area.

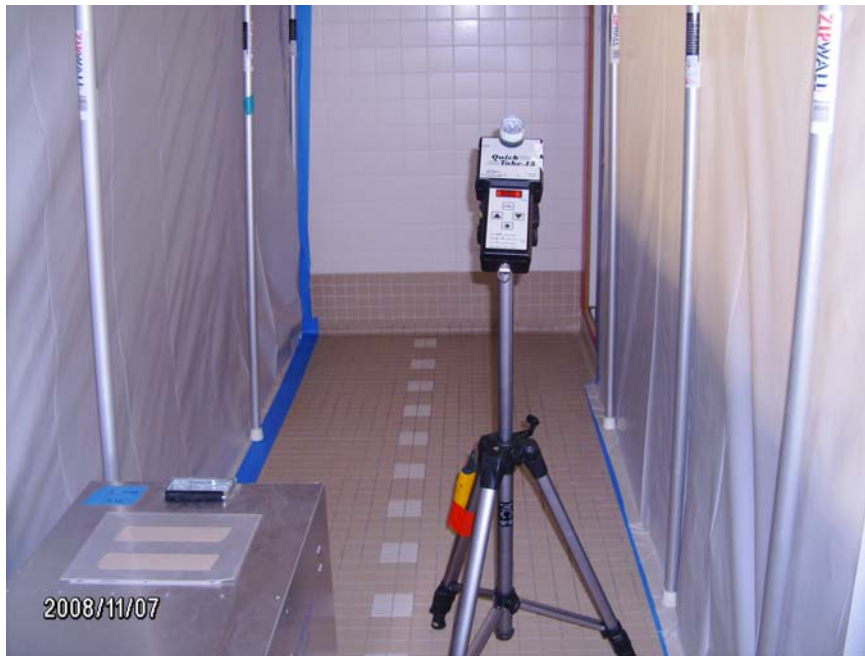
- 9) Image of air sampling equipment and critical barriers erected within LCD-C-5 containment system at time of assessment.

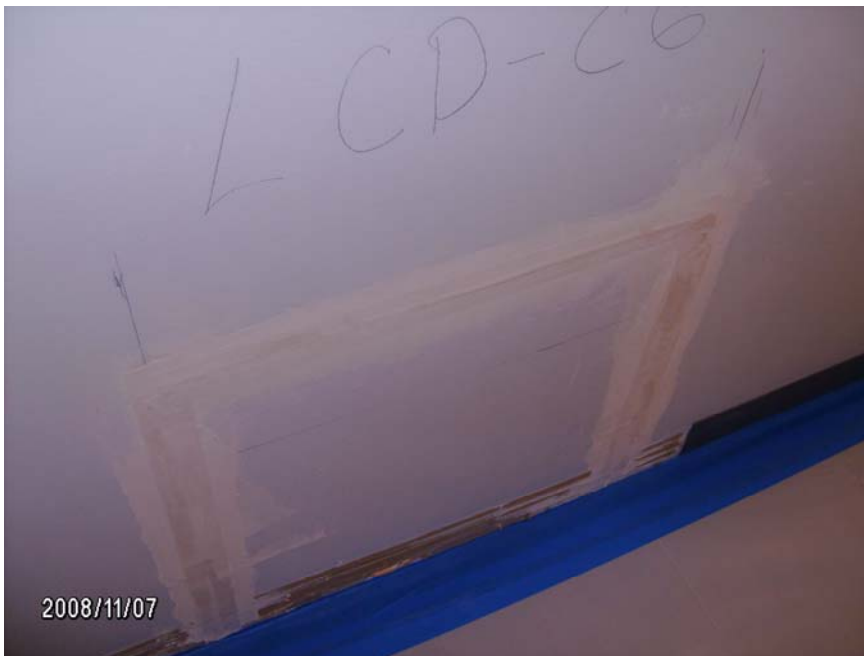
- 10) Image of baseboard removal and wallboard repair following LCD's inspection within LCD-C-6 at time of clearance assessment.

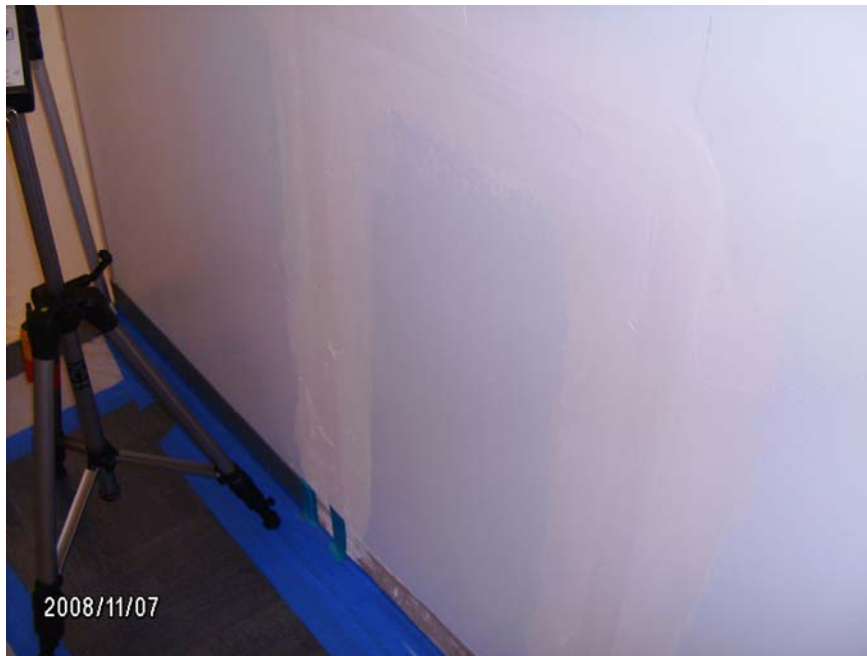
11) Image of wallboard repaired following LCD inspection within LCD-C-7 containment at time of assessment.

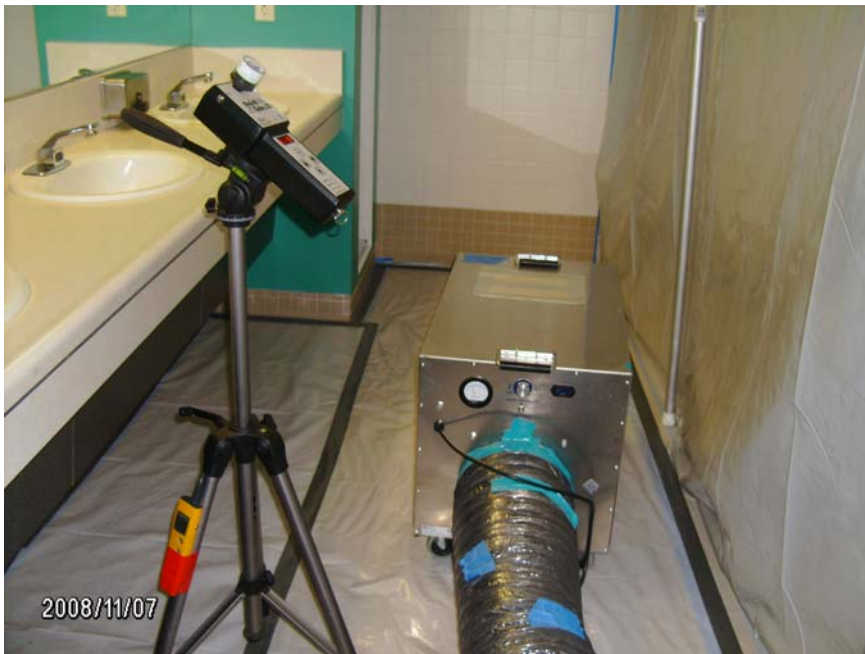
12) Image of air sampling and air handling equipment within men's restroom LCD-C-8 containment at time of assessment.

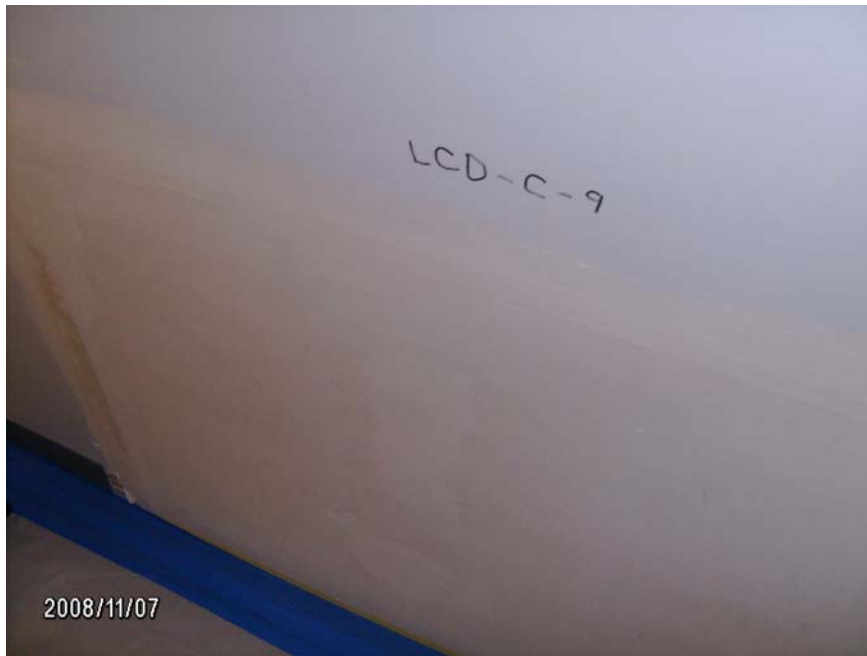
13) Image of wallboard repaired following LCD inspection within LCD-C-9 containment at time of assessment.

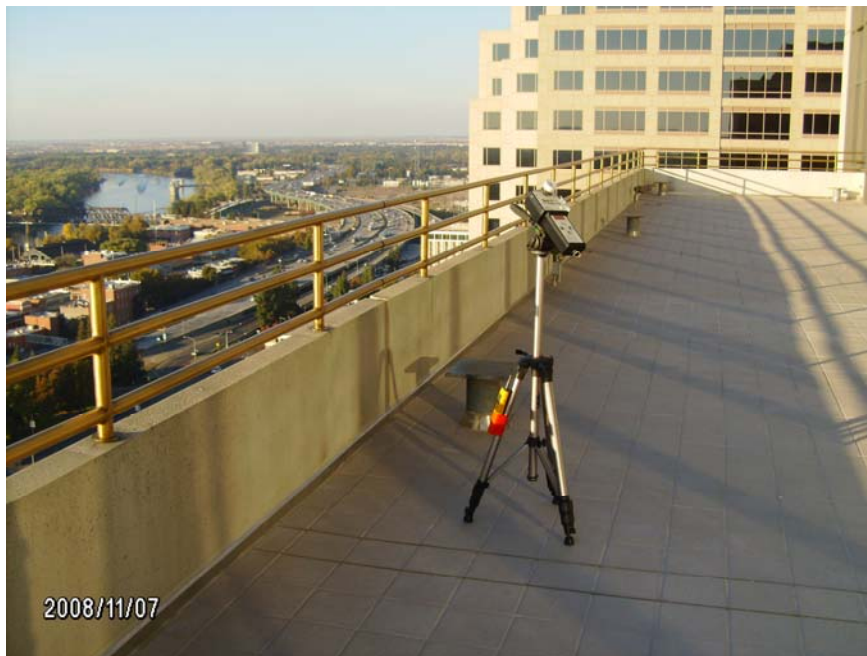
14) Image of ambient air sampling location on 23rd Floor Western Balcony of BOE building performed at conclusion of interior clearance inspection sampling.
